SERVICE BULLETIN

Date: 11/24/2021

**IMPORTANT SAFETY INFORMATION REGARDING CERTAIN FRONT TELESCOPIC HOIST CYLINDERS SOLD BY CRYSTEEL OR INCORPORATED INTO TRUCK BODIES SOLD BY CRYSTEEL**

**Subject:** Crysteel Marathon telescoping hoist cylinder manufactured by Hyco Alabama, LLC.

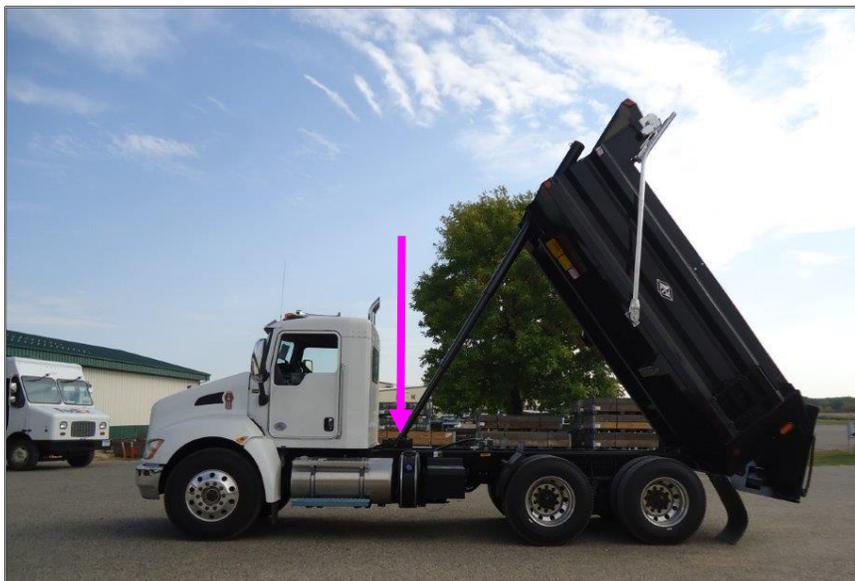
Location of the hoist cylinder cradle mount pin when viewed from the driver's side of the work truck.

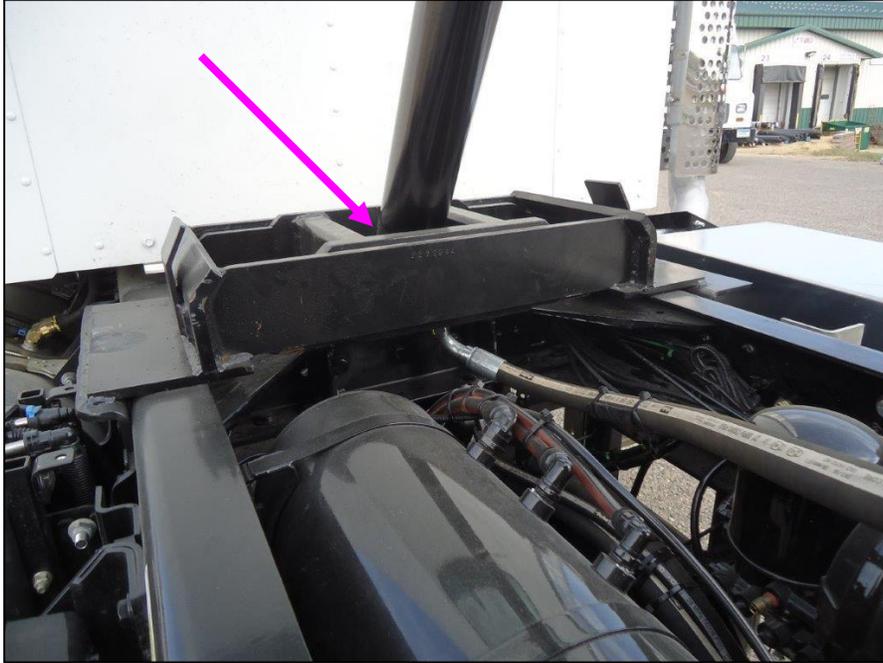
Rod end of cylinder positioned inside the hoist cradle on the truck chassis.

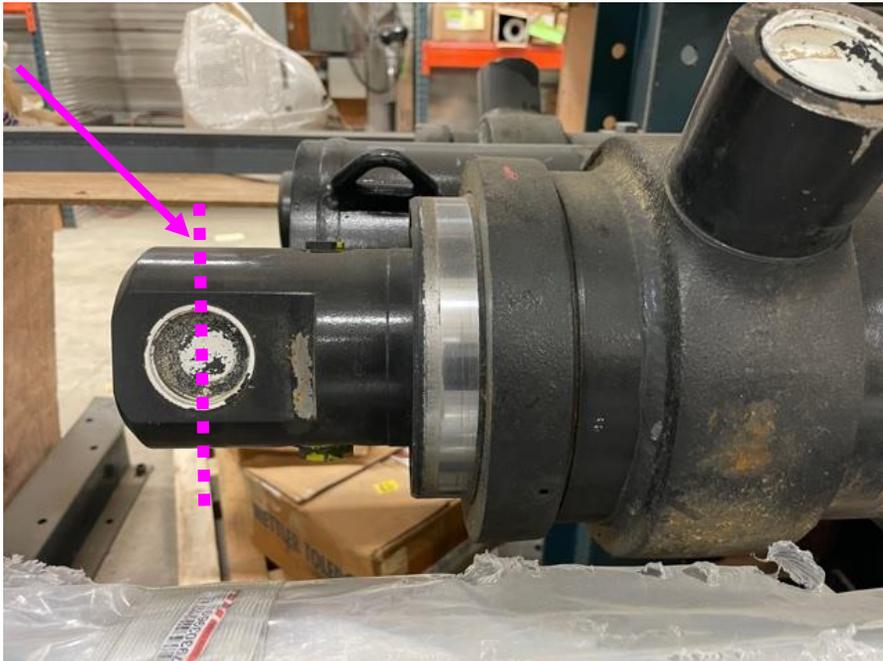
Rod end of cylinder shown with example of indication of potential failure zone.

Crysteel has received a small number of reports which indicate that “Black Armor” model cylinders supplied to it by Hyco Alabama, LLC during 2020 and 2021 and sold by Crysteel have experienced cracks at the surface of the cylinder rod around the area of the cradle attaching pin. These cracks reportedly have led to cylinder failures. If a cylinder fails, it may create a risk of serious bodily injury and/or damage to truck bodies. Black Armor cylinders can be identified visually as the cylinder stages will be dark-colored rather than chrome-finished. This notice does not apply to chromed cylinders sold by Crysteel.

Crysteel recommends visually inspecting all hoists daily in trucks equipped with Black Armor model cylinders, prior to the start of operation. Specifically, the cylinder rod at the pin connection should be inspected carefully to note if there are any cracks observed in the area shown. Stress and fatigue can manifest itself in the form of cracking in the rod area surrounding the cradle pin. The inspector should inspect for any evidence of cracking or separation occurring in or around the pinned connection of the cylinder rod. If any sign of cracking or fatigue

is found in the cylinder rod, or any other unusual signs of potential issues at the cylinder pin location, do not operate the vehicle and contact Crysteel Mfg Warranty for further information.

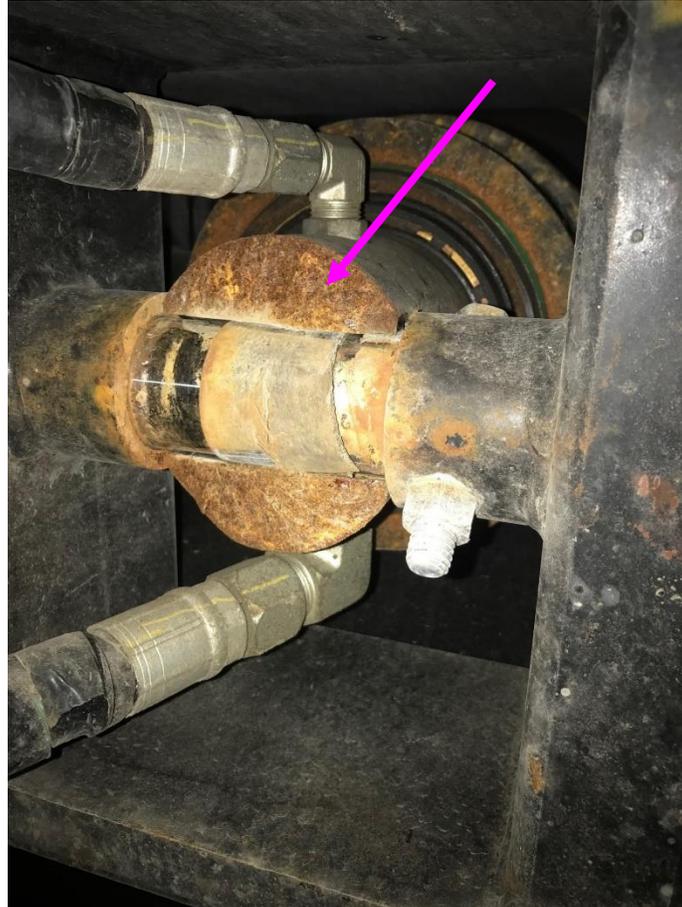
Rod end of cylinder shown with example of indication of potential failure zone when viewed from underside of truck hoist chassis cradle. Actual instances of failure may vary.

**Caution:** Be sure to inspect the rod end with the body in the LOWERED position, PRIOR to starting the truck.

Inspectors should not raise the truck body while conducting this inspection, but should conduct the inspection from the underside of the truck hoist chassis cradle. Follow all appropriate safety precautions in conducting this inspection.

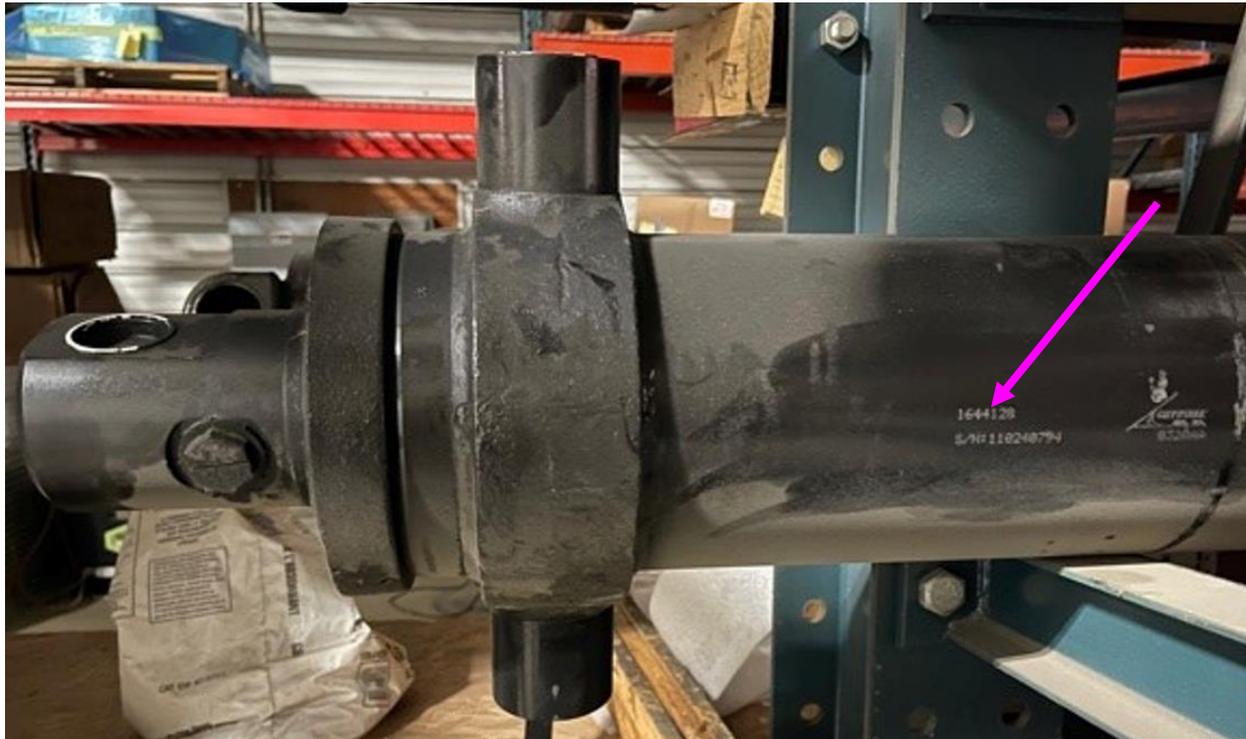
Cylinder Part Numbers affected in this Bulletin

Arrow shown above is pointing to where you will find the Cylinder Part and Serial Number
